*DoD Corrosion Prevention and Control Program*

## **Implementation of Remote Corrosion- Monitoring Sensor for Mission-Essential Structures at Okinawa**

Final Report on Project FAR-04 for FY06

August 2009

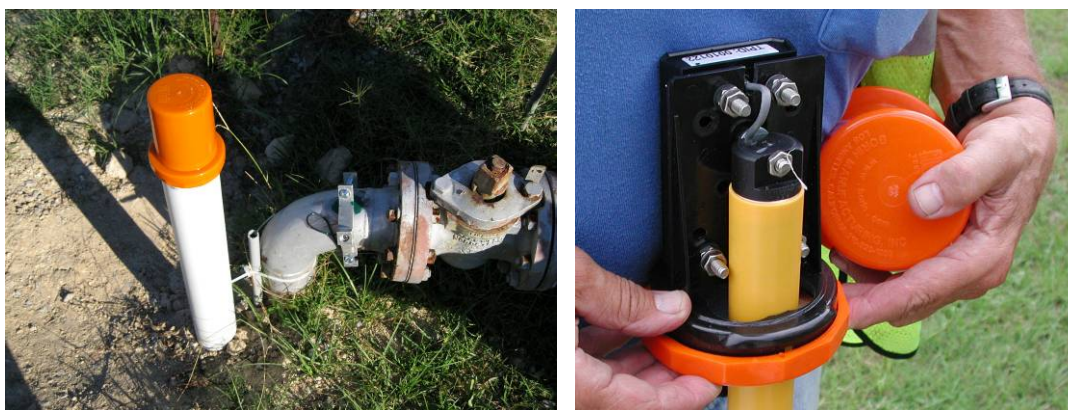
FIGURE 4 – (Left) Typical Pipe Protection Remote Monitoring Units Installed to Interrogate the Pipeline and Transmit System Corrosion Control Effectiveness Data. (Right) Remote Monitor Unit with Cap Removed Showing Terminal Connection Points.

The battery operated remote monitoring system uses 10 – 15 year life replaceable batteries. Installation maintenance personnel drive through the Installation once a month with a standard PC portable computer connected to a small radio transmitter/receiver with a magnetic antenna temporarily mounted on a pickup truck roof (see Figure 5). A GPS unit monitors both the vehicle location and shows all 106 monitoring points distributed around the base on map displayed on the PC screen. Six of these monitor locations measure the output of the six DC power supplies used to energize the ICCP systems, while the other 100 units monitor the corrosion control effectiveness at key locations throughout our buried gas piping system throughout the installation. It is anticipated that it will take as little as 2 hours to accomplish the entire ICCP survey, compared to the 5-10 days that it would take for a trained technician's time to do the same work. As an additional benefit, the data is then automatically transferred in to an Excel spreadsheet where it is automatically analyzed on a "pass/fail" basis.

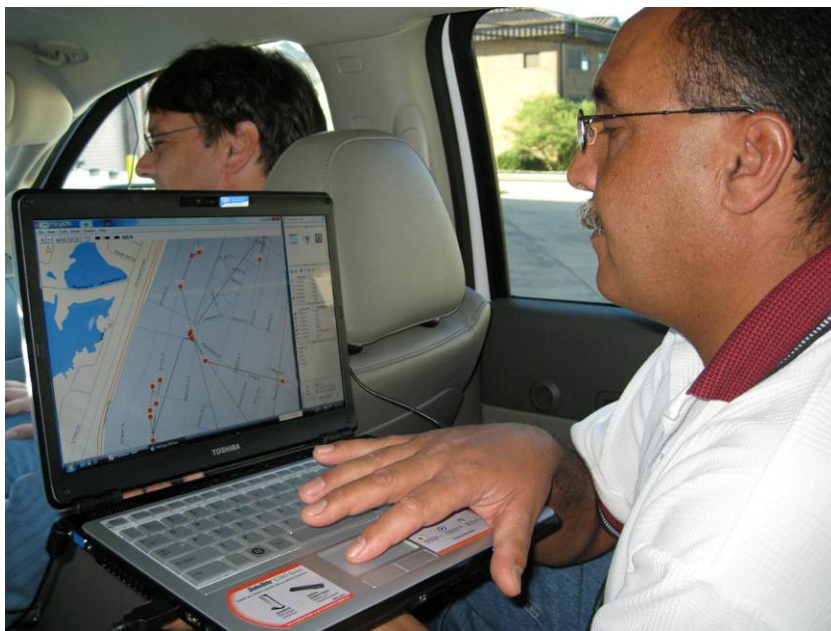
FIGURE 5 – Army Installation personnel can use laptop PC to automatically interrogate and record CP protection levels while being driven by each monitoring station.

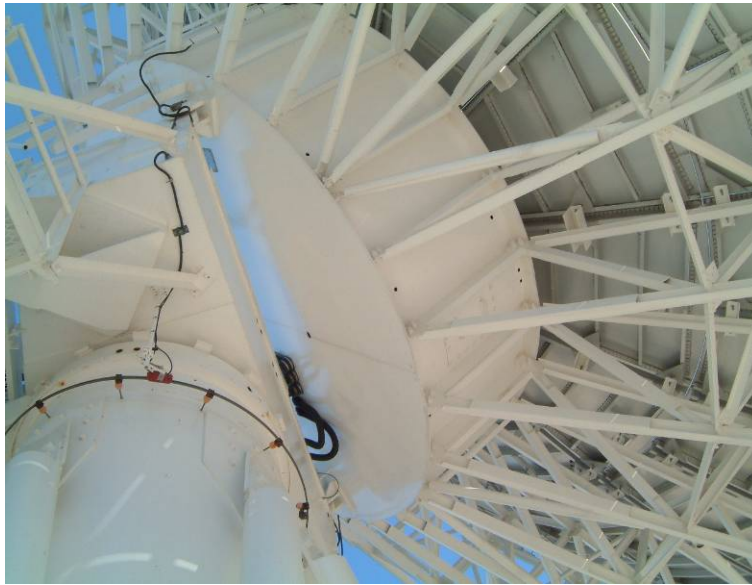
Figure 1: The hub of the dish is located on the edge of the stalk and difficult to access for inspection

The dish antennas that were inspected at Torii have recently been overhauled and coated. They provided an excellent window into the onset of corrosion on the structures. Corrosion initiation sites are already clearly visible. Despite the relatively new coating, any area that has been exposed to any form of wear or metal particle contamination seems to suffer virtually instant corrosion.

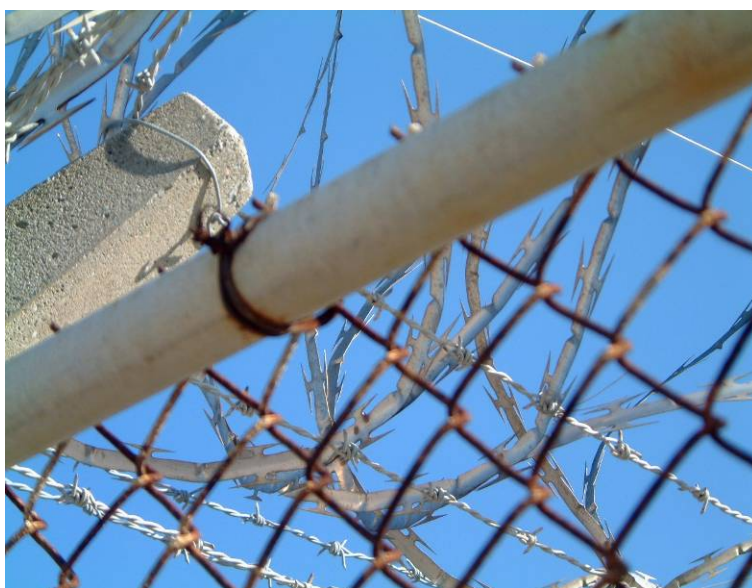
Figure 2: The relative corrosion rate of stainless steel and galvanized steel is striking, but stainless steel fences are economically impractical at ten times the cost of galvanized steel

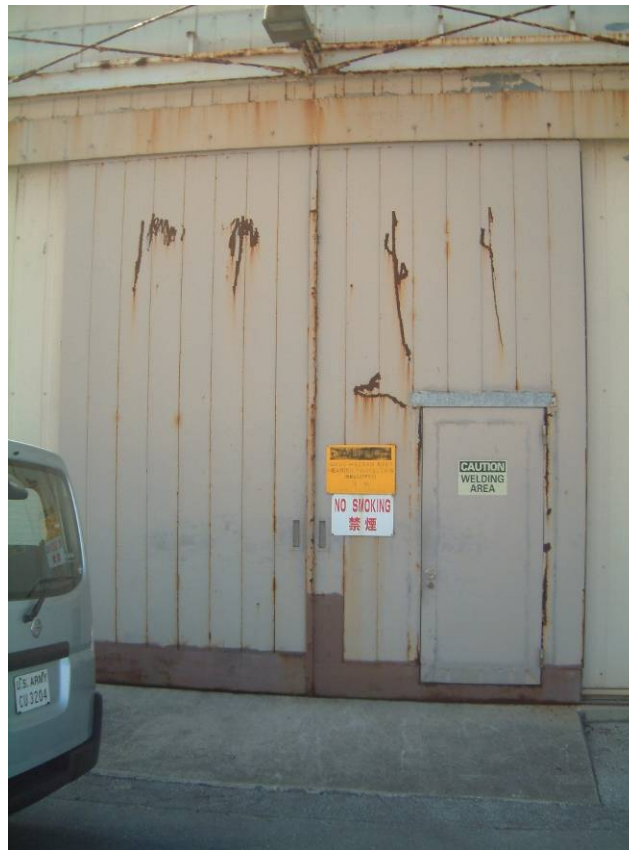
Figure 3: Safety critical buildings suffer degradation due to corrosion and are neglected

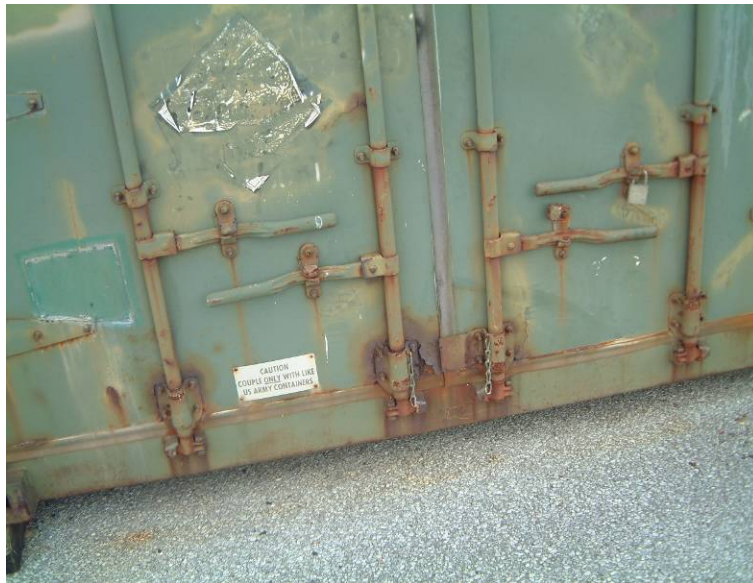
Figure 4: The containers tend to corrode at the bottom, on hinges and on their roofs

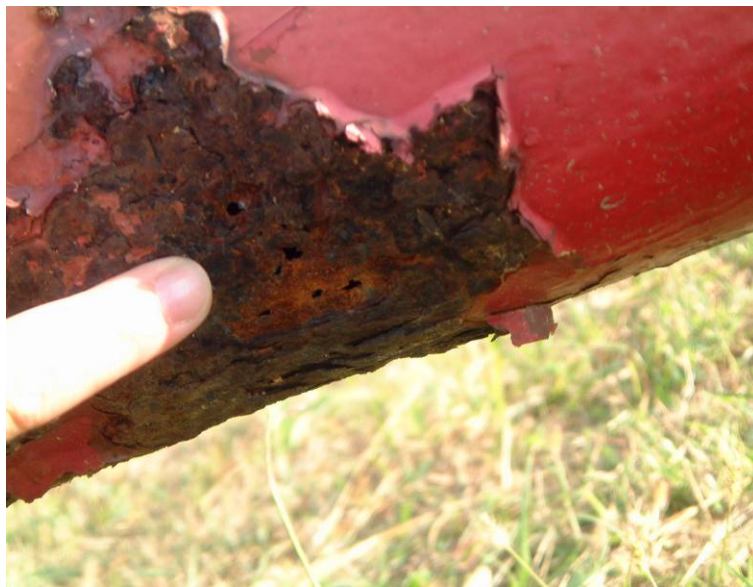
Figure 5: In some cases, the corrosion has been so severe that the pipe has failed

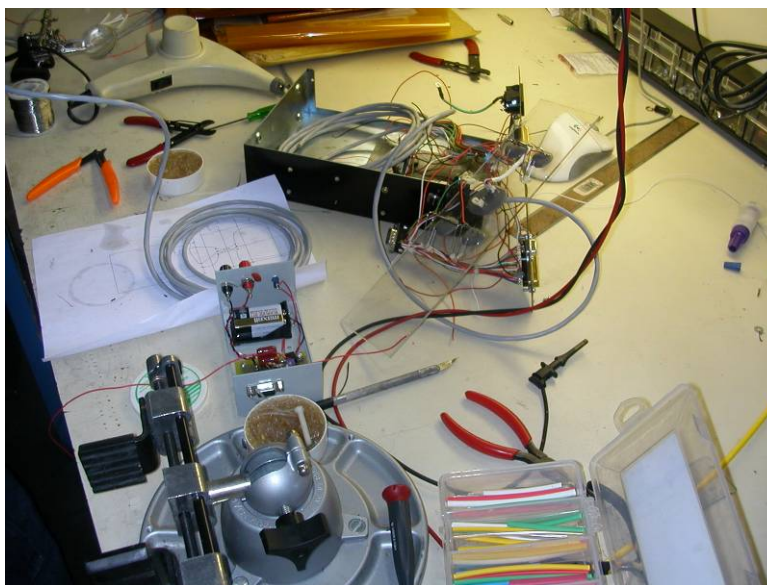
Figure 3: Attaching Wires to the Sensors.
